**2005
PROJECT
STRUCTURE REPORT**

**INSPECTION OF
FLOOD CONTROL STRUCTURES ON THE
SACRAMENTO AND SAN JOAQUIN RIVERS
AND THEIR TRIBUTARIES**

**Prepared By
The Flood Operations Branch**

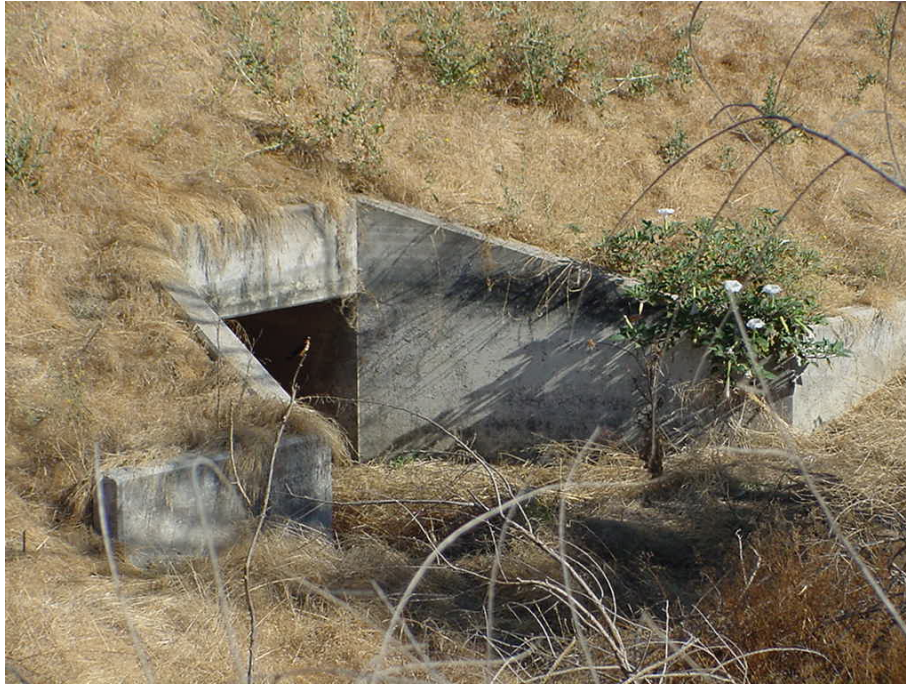
The intake side of the structure.

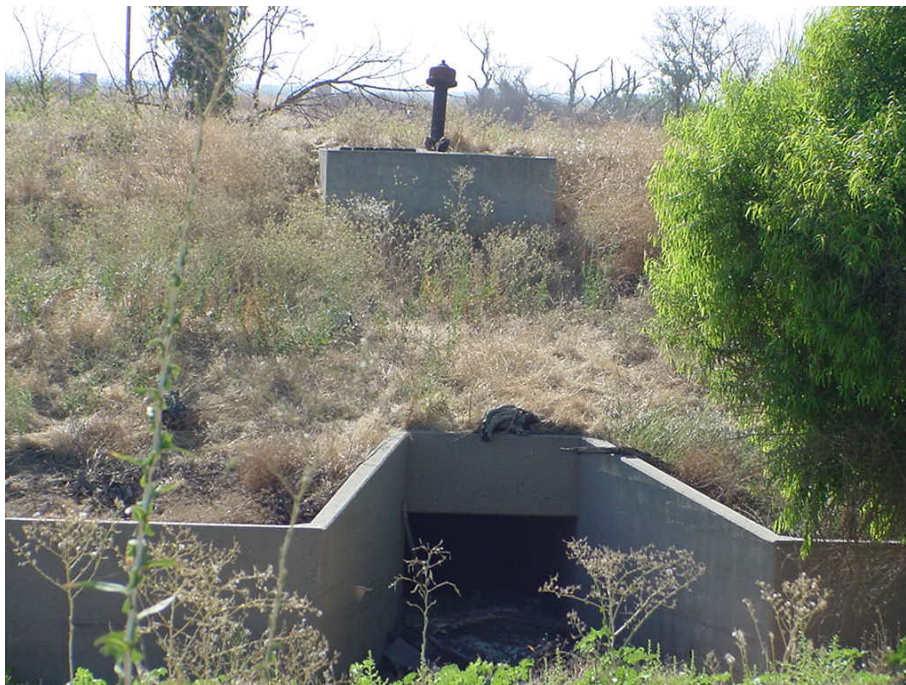
1. Condition of concrete drainage structure.
 - a. Good.
2. Condition of abutments and wing walls.
 - a. Good.
3. Condition of control gate, mechanism, and flap gate.
 - a. The control gate mechanism is bent.
4. Condition of revetment.
 - a. Good.
5. Accumulation of trash and debris around the structure or in the channel.
 - a. Good.
6. Vegetation around the structure or in the channel.
 - a. Moderate.
7. Comments:
 - a. Repair the control gate mechanism.
 - b. Fair maintenance.

The discharge side of the structure and the control mechanism.

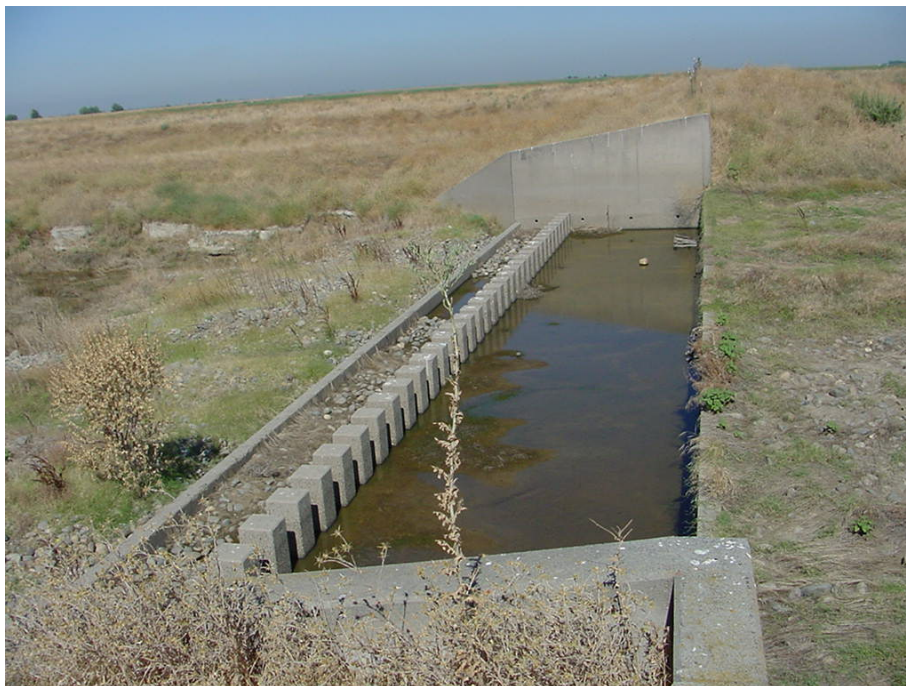
The abutments, stilling well and velocity dissipaters.

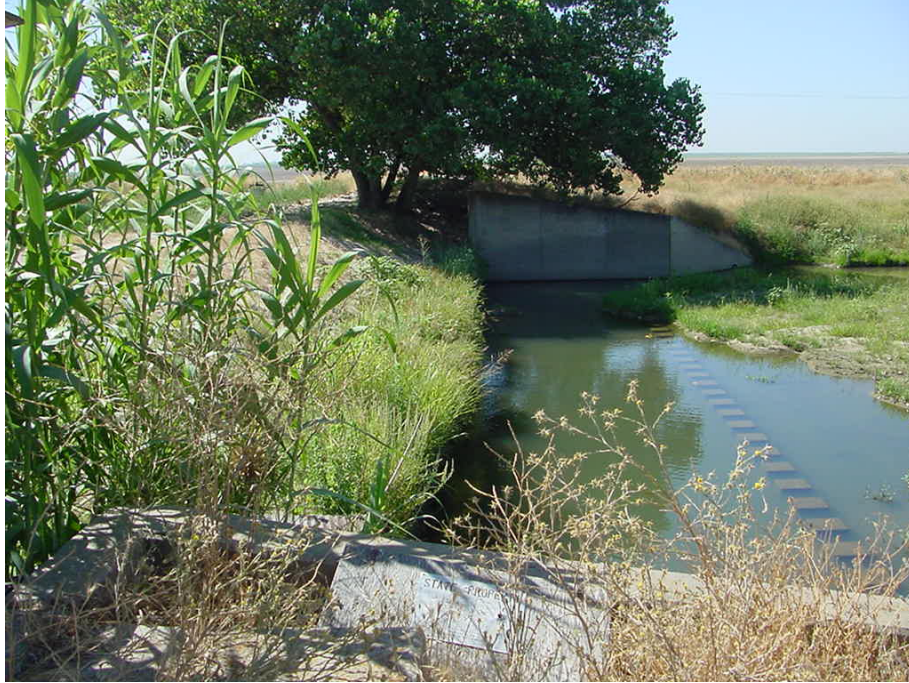
1. **Condition of concrete drop structure, stilling basin, and velocity dissipaters.**
 - a. **What can be seen is in good condition, but a seasonal sand dam is in place backing up water for irrigation purposes on the upstream side.**

- a. **None.**
5. **Vegetation around the structure or in the channel.**
 - a. **Minimal.**
6. **Condition of the gauging house and equipment.**
 - a. **The gauging house is completely non-functional. A placard on the damaged door indicates that this is a DWR gauging station.**

The downstream side of the drop structure and the seasonal sand dam.

- b. **Remove bamboo.**
 - c. **Determine the status of the gauging house and report findings to the Flood Project Inspection Section.**
 - d. **Unable to perform an adequate inspection of the structure due to the sand dam.**

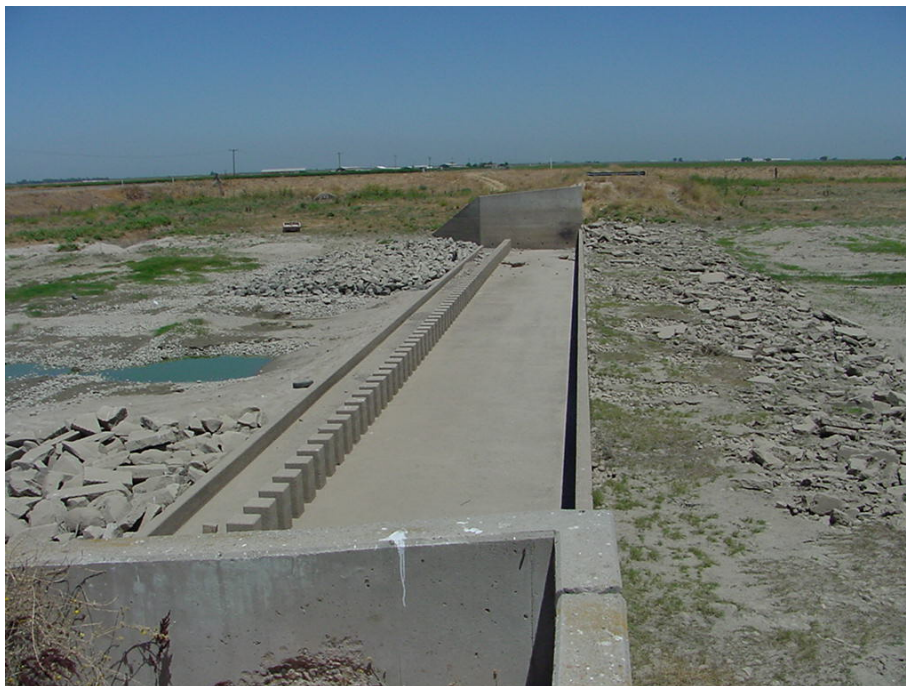
Overview of the stilling basin and the velocity dissipaters.

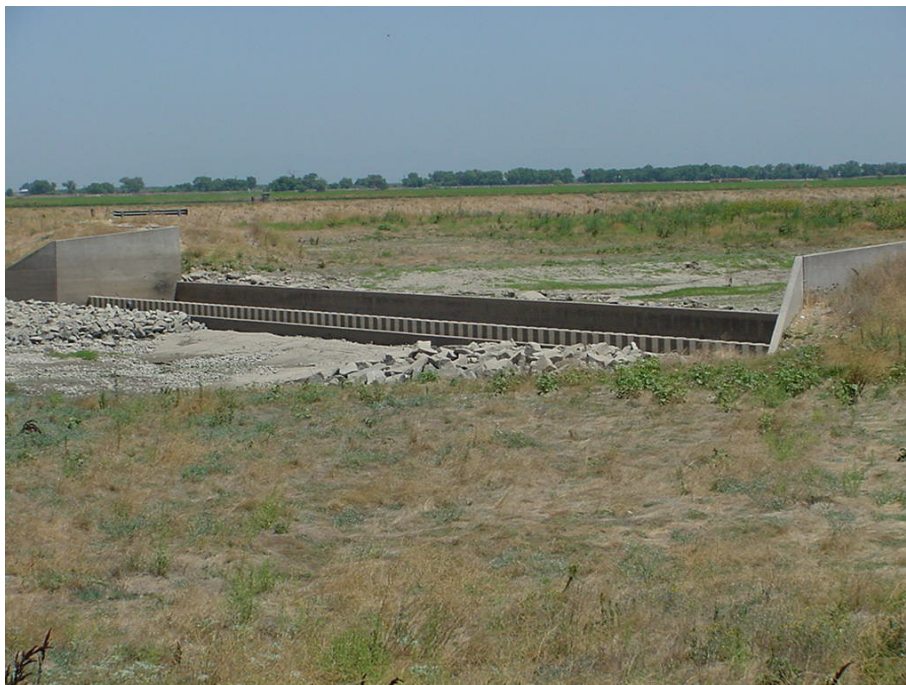
Looking northeast at the drop structure.

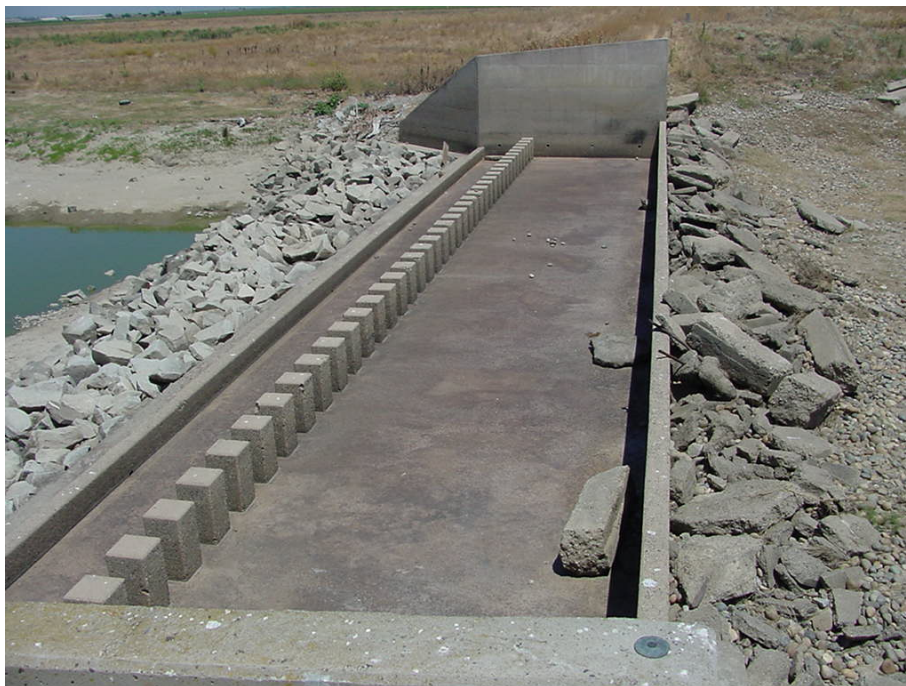
Overview of the stilling basin, velocity dissipaters and revetment.

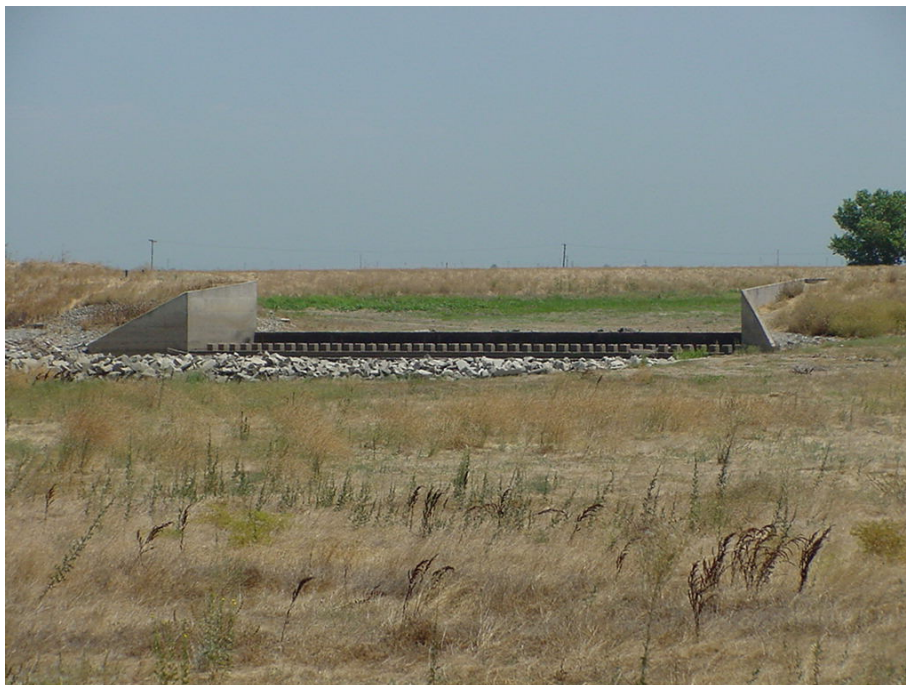
Looking east at the drop structure.

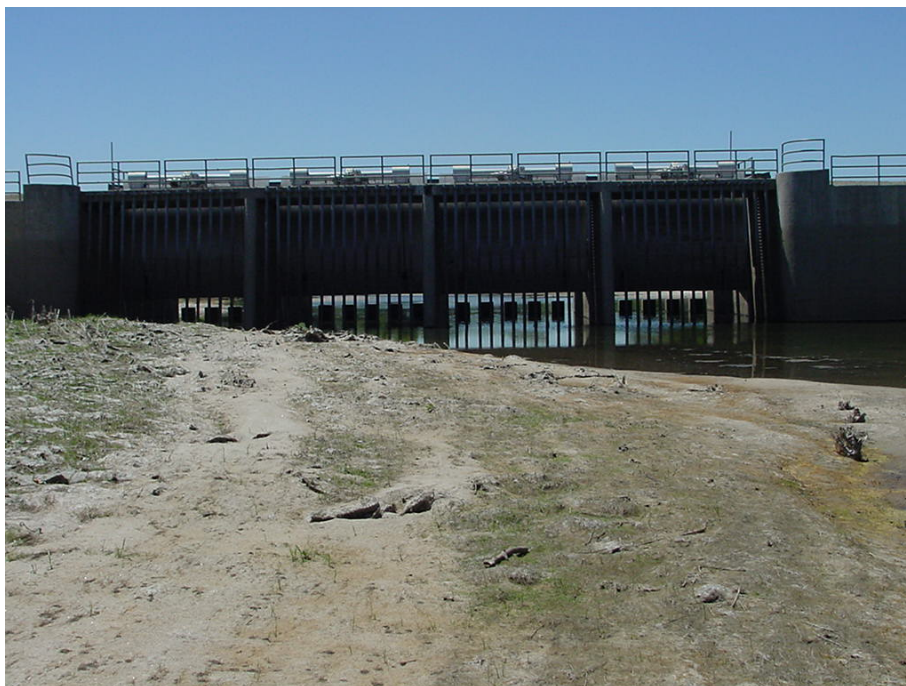
The upstream side of the San Joaquin River structure.

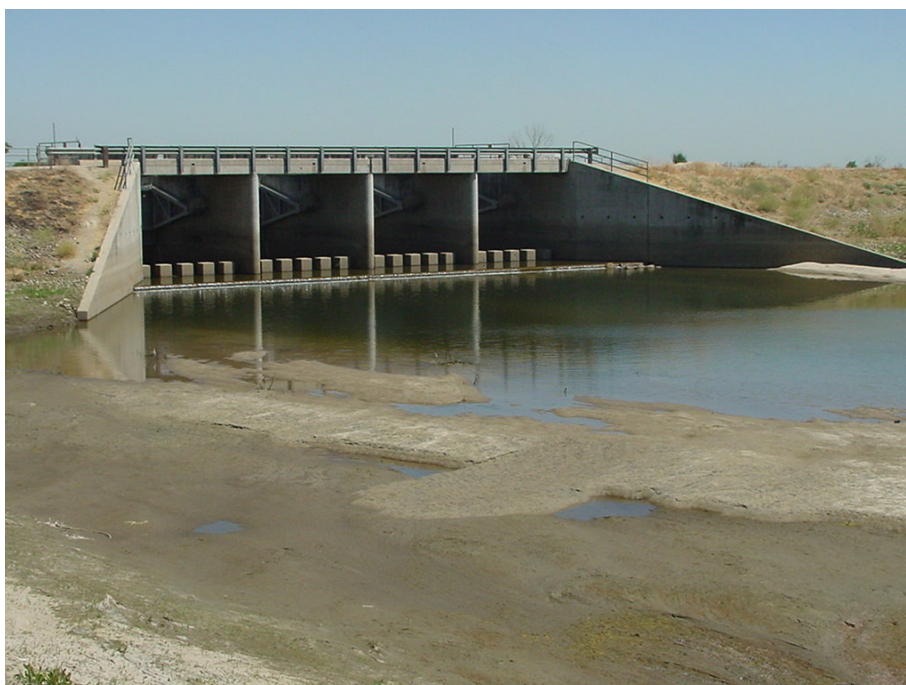
The downstream side of the San Joaquin River structure.

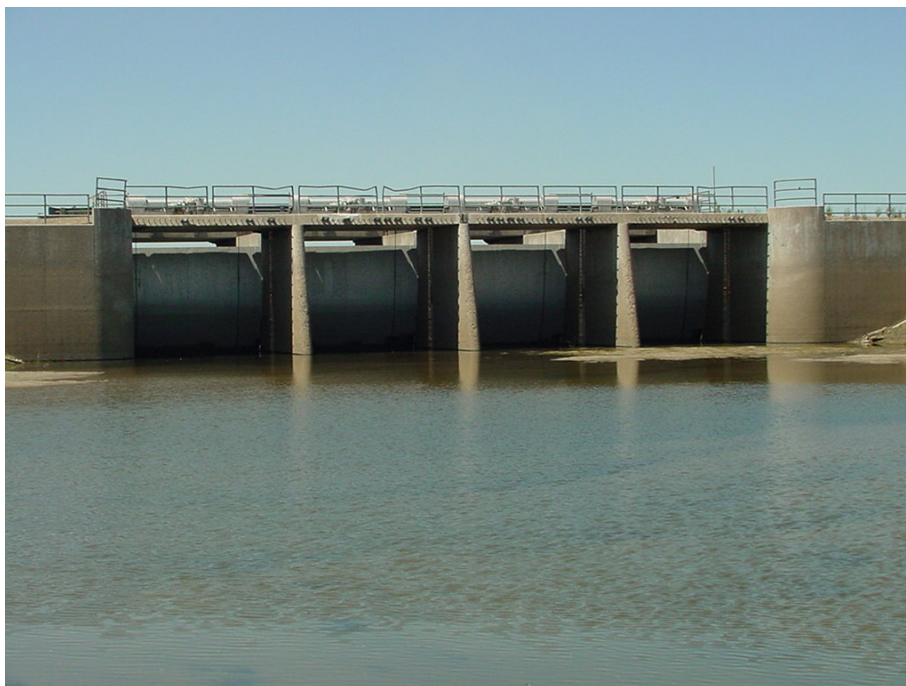
The upstream side of the Chowchilla Canal Bypass structure.

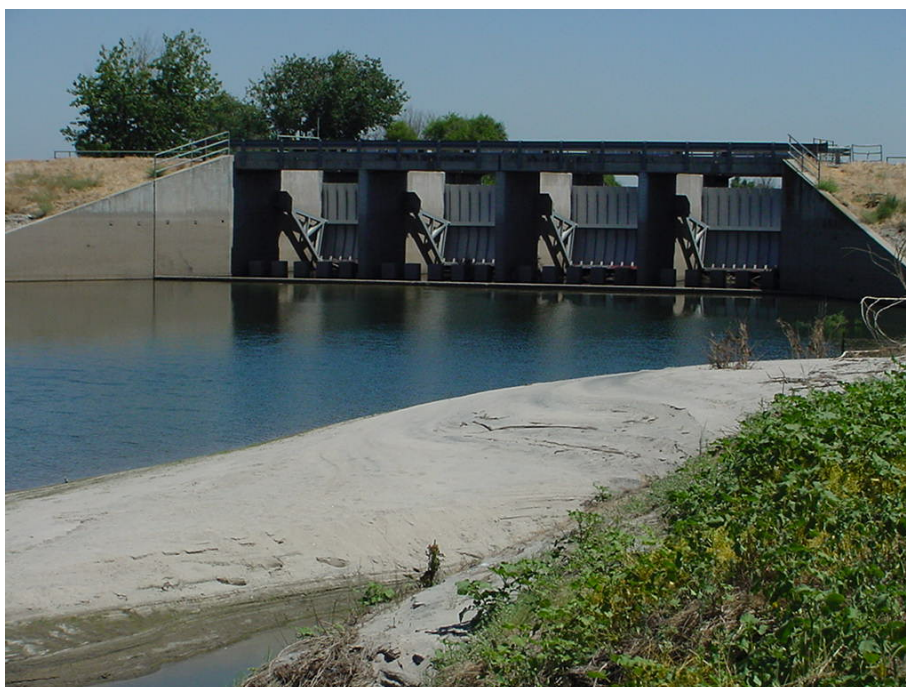
**The downstream side of the structure
into the Chowchilla Canal bypass.**
